# An NDE Approach for Characterizing Quality Problems in Polymer Matrix Composites

Prepared for the  
40th International Symposium and Exhibition  
sponsored by the Society for the Advancement of Materials and Process Engineering  
Anaheim, California, May 8-11, 1995

| REPORT DOCUMENTATION PAGE | | | Form Approved<br>OMB No. 0704-0188 | |
|---|---|---|---|---|
| 1. AGENCY USE ONLY (Leave blank) | | 2. REPORT DATE<br>December 1994 | | 3. REPORT TYPE AND DATES COVERED<br>Technical Memorandum |

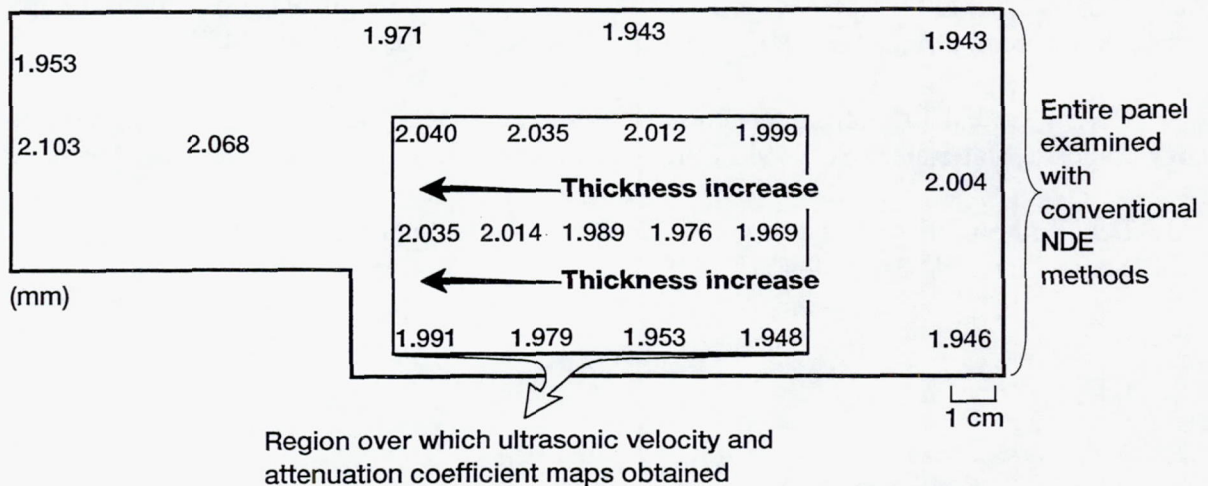
**2.1 Material** The panel in this study was a 12-ply unidirectional laminate composed of 40 vol % N-CYCAP resin (1) and 60 vol % T40-R graphite fiber (unsized) in 12000 fibers/tow (Figure 1). It was processed using simulated autoclave vacuum bag methods with final processing conditions of 200 psi (press assist) at 371 °C (2). The panel dimensions were 20.5 cm by 7.5 cm by ~ 0.2 cm thick. The thickness of the panel was measured at 20 locations across the panel. For these locations, thickness varied from 1.946 mm to 2.103 mm, a variation of 0.157 mm. The following trends in thickness were noted: 1) the top and bottom edge areas were generally 0.050 to 0.150 mm less thick than the interior regions and 2) thickness increased from right to left along several interior lines in the panel as shown in Figure 2. The variation in the thickness complicated conventional ultrasonic and radiographic analyses since thickness increases attenuation in both modalities.

Figure 2.—Panel thickness variation (numbers indicate thickness in millimeters). Thickness is lowest at top and bottom edge areas; interior thickness increases from right to left.

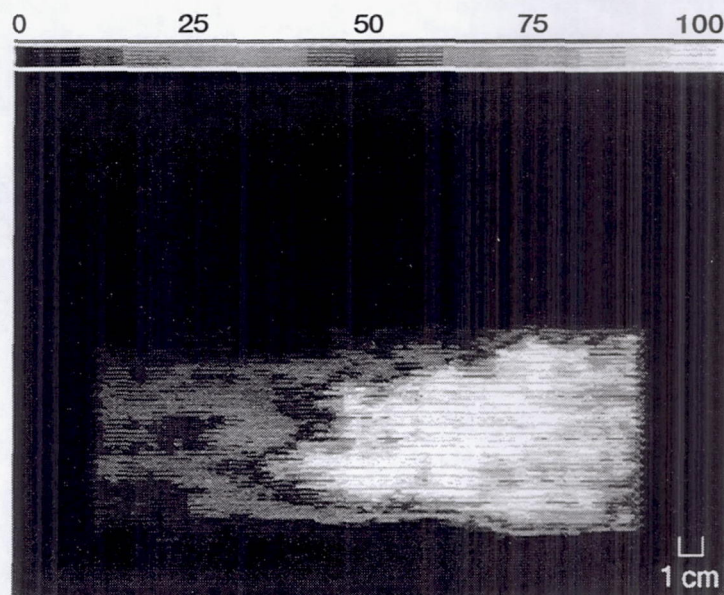
**3.1 Conventional NDE** Figure 4 shows the image generated by mapping the peak height of the wave transmitted through the PMC panel in the initial c-scan screening procedure. Figure 5 shows the image generated by mapping the peak height of the echo reflected from the panel back wall during the high resolution pulse-echo c-scan. In both images, white, black and gray color represent low, high and intermediate ultrasonic attenuation, respectively. As shown in Figures 4 and 5, The PMC panel was observed from the immersion ultrasonic procedures to

exhibit a "wavefront" nonuniformity. The wavefront pattern indicates a fairly continuous gradient from right to left of lower to higher attenuation, respectively. Given that the surface condition was uniform across the panel, it can be concluded from the image and the waveform amplitudes that the left end of the panel contained some attenuating microstructural anomaly or thickness increase as compared to the right end.

- Initial quality screening
- Note "wavefront-like" nonuniformity
- White is lowest attenuation
- Grey is intermediate attenuation
- Black is highest attenuation

Figure 4.—Ultrasonic through-transmission C-SCAN (5 MHz).

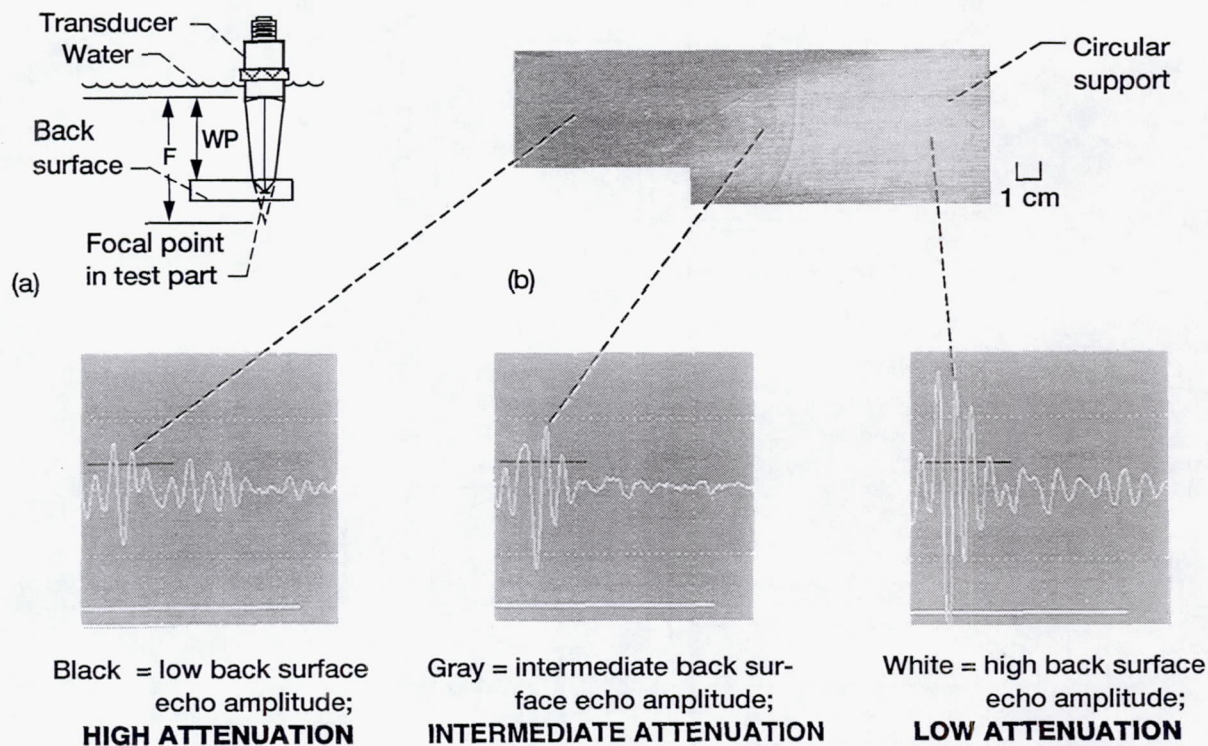
Figure 5.—High-resolution back echo ultrasonic C-SCAN. Back surface echo gate for volumetric imaging.  $F$   $\equiv$  nominal focal length.  $WP$   $\equiv$  water path length. (a) Schematic of set-up for back surface echo gating. (b) Back surface echo image and back surface echoes at three locations.

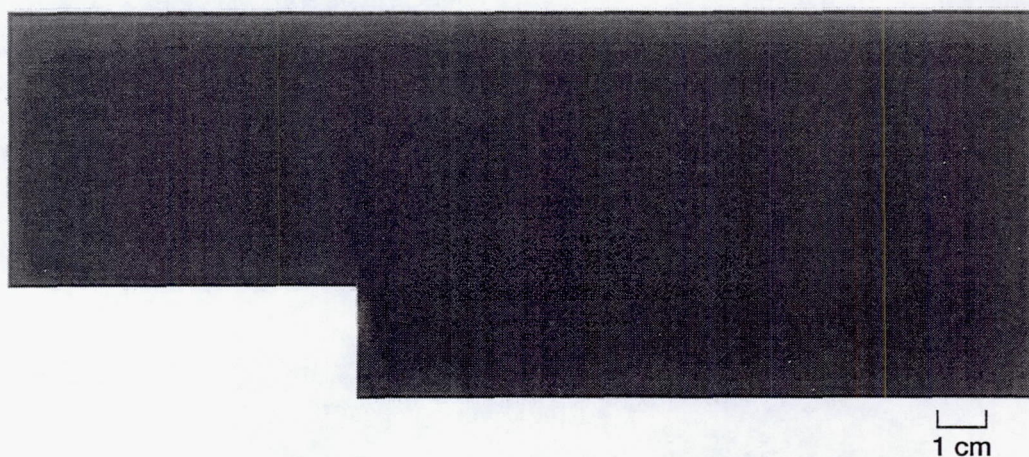
The radiographic print shown in Figure 6 indicates a uniform gray scale indicating little or no nonuniformity. This was puzzling considering the ultrasonic immersion results shown in Figures 4 and 5; the explanation will be provided in later discussion.

It is also possible to explain the relative uniformity of the radiograph shown in Figure 6. Again, thickness variation can mask or exaggerate microstructural variation on x-ray attenuation images depending on the spatial relation of the variations. Thickness increase causes an increase in x-ray attenuation while pore fraction increase causes a decrease in x-ray attenuation. Since thickness and pore fraction generally increased from right-to-left across the panel, the effect due to the thickness increase masked the effect due to the pore fraction increase in the x-ray attenuation image. Thus, the x-ray print appeared relatively uniform.

Figure 6.—Film radiography. Source-to-panel distance = 30 in., 60 kV, 25 mA, 2 min. Panel appears uniform. Indicates density variations below  $\sim 2\%$  if thickness variations insignificant.

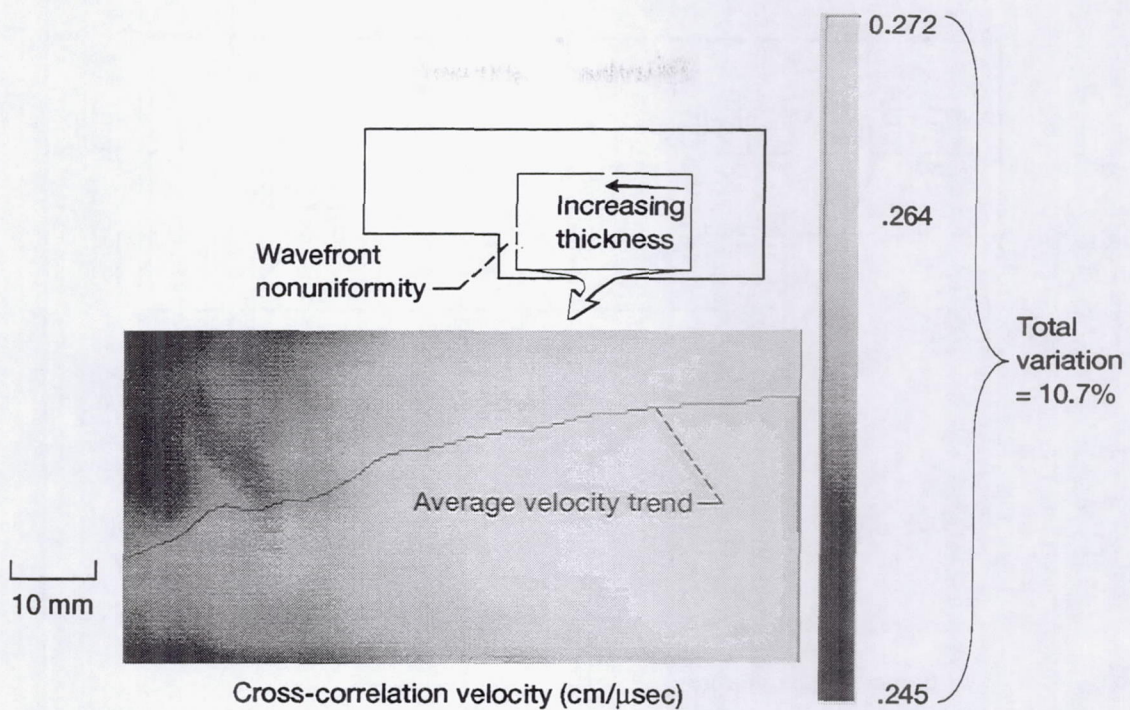
**3.2 Unconventional NDE: Ultrasonic Contact Scanning** Figure 7 shows the velocity image derived from the ultrasonic contact scan performed over the transition region of the wavefront nonuniformity. The image is presented with a line drawn across it which shows the average velocity trend across the sample region and indicates decreasing velocity from right to left. Higher-to-lower velocity variation such as this is usually attributable to increasing thickness or a microstructural component gradient (4,5). The total velocity variation across the scanned region was 10.7% as calculated from:

The time delay error,  $\Delta T$  only contributed 0.1% to the percent velocity variation. Using  $\pm 0.050 - \pm 0.100$  mm as a range for thickness variation  $\Delta T$  over the scanned region, thickness variation contributed 2.5–5% to the percent velocity variation. From Equation 2, the latter results leaves 5 – 7.5% variation above and beyond that due to time delay error and thickness variation. Thus, it was concluded that a microstructural gradient must have been responsible for the remaining velocity variation. Note that it was possible to quantify the variation associated with the microstructural variation only by using the velocity mapping method and error analysis in conjunction with thickness measurements. A new imaging method presently being commercially developed in a cooperative effort between NASA and Sonix, Inc. uses a single transducer scan procedure to eliminate thickness effects. Thus, the resulting image will show only true microstructural variation.

**3.4 Correlation of NDE results with Microstructure** Based on the error analysis results for velocity mapping, the pore fraction gradient observed in the panel was responsible for the percent velocity variation above and beyond that due to thickness variation seen in the velocity map. Although the pore fraction *over the region of the velocity map* increased only  $\sim 1\%$  from right-to-left as measured from the optical image analysis, this increase accounted for a 5–7% decrease in velocity (excluding that due to thickness variation and time delay error). The decrease in velocity with increasing pore fraction is consistent with previous investigations for other materials, although the 5–7% decrease in velocity for a 1% increase in porosity is larger than that seen previously for metals and ceramics (6).

Figure 7.—Ultrasonic velocity mapping. Left-to-right velocity variation indicates thickness and/or microstructural gradient.

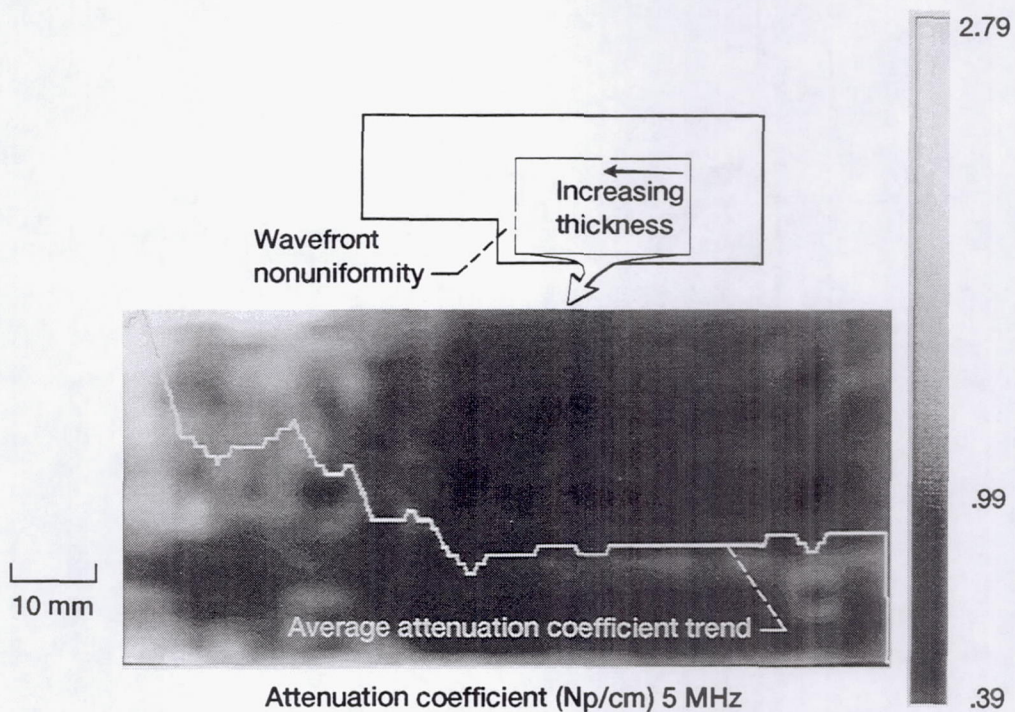
The attenuation coefficient map of the same region is presented with a line drawn across it in Figure 8. The line shows the average attenuation coefficient trend across the sample region and indicates increasing attenuation coefficient from right to left which is consistent with increasing sample thickness and / or greater scattering (4). A much more complicated error analysis than that used for velocity variation is necessary to separate effects on attenuation coefficient variation due to thickness and microstructural effects (4). A recent study showed a novel two transducer method for obtaining attenuation images independent of thickness (8).

With regards to velocity and attenuation mapping for both contact and immersion scanning, thickness variation can mask or complement microstructural variation depending on whether it spatially opposes or complements the microstructural variation. In this investigation, thickness increased (causing apparent velocity decrease and attenuation increase) in the same direction as pore fraction increased (causing real velocity decrease and attenuation increase) so that the effects complemented each other with regards to velocity and attenuation measure. It has been previously exhibited that attenuation increases with increasing thickness and increasing pore fraction in graphite - polymer composites (10).

Figure 8.—Ultrasonic attenuation coefficient mapping. Left-to-right attenuation coefficient variation indicates thickness and/or microstructural gradient.

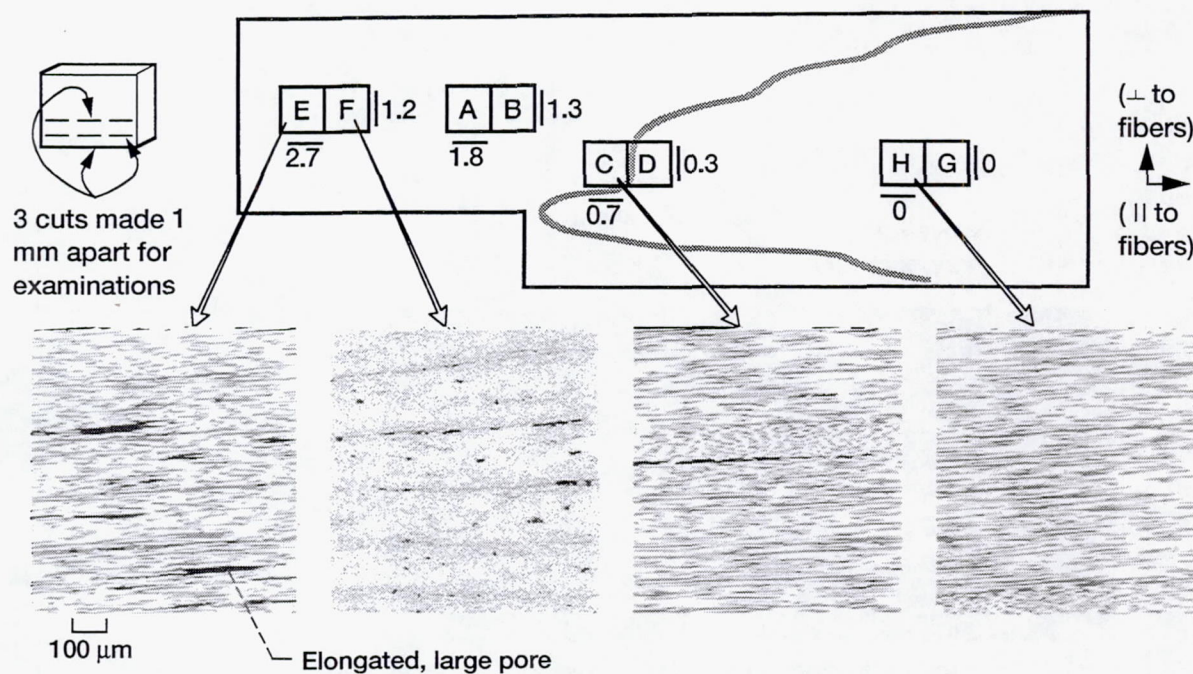
**3.3 Destructive Characterization: Optical Image Analysis** In viewing the cross-sections cut from the panel, it was apparent that a pore fraction gradient existed across the panel from right-to-left. The average percent porosities obtained from image analysis are given next to the section labels in Figure 9. The porosity was elongated in the direction of the fiber; hence the consistent difference in pore fractions for the two different viewing orientations. In the direction parallel to the fibers, average percent porosity increased from  $\sim 0\%$  at the right end to  $0.7 \pm 0.3 \%$  in the center

to  $2.7 \pm 0.8\%$  at the left end of the panel. The processing step where the pores originated needs to be determined. Pores in PMCs can result from a number of sources including trapped air in fiber bundles, condensation reaction procedures, residual solvent from prepregging, low molecular weight polymer chains that degrade and volatilize during processing, and decomposition of larger polymer chains during high temperature processing or post processing (postcure). Two possible causes of pore fraction *variations* in PMCs include a misaligned platen causing uneven pressure during pressing, or one end of the panel "stiffening" so resin flow is impeded during pressing. The pore fraction variations seen in the panel can lead to significant property variation. For example, it has been observed that interlaminar shear strength was reduced 15% when percent porosity increased from 0 to 1% in PMC material (9).

Figure 9.—Destructive sectioning and optical image analysis. Numbers show % porosities. Note porosity gradient (high at left and low at right).

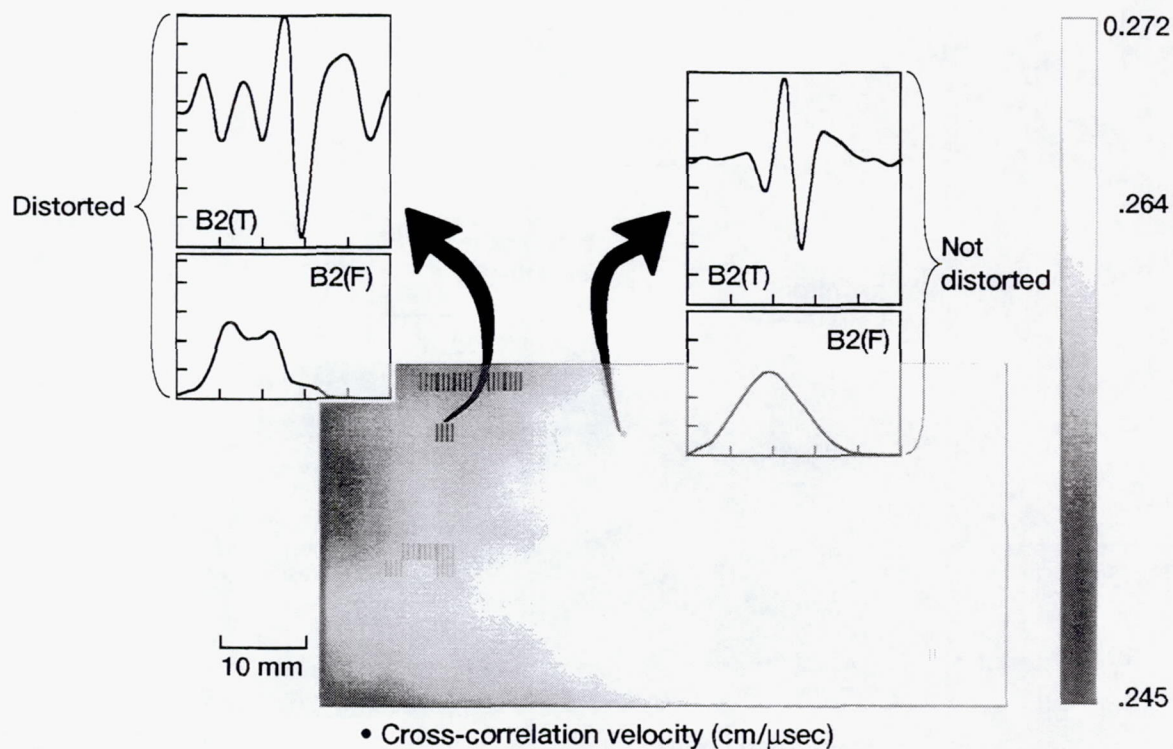
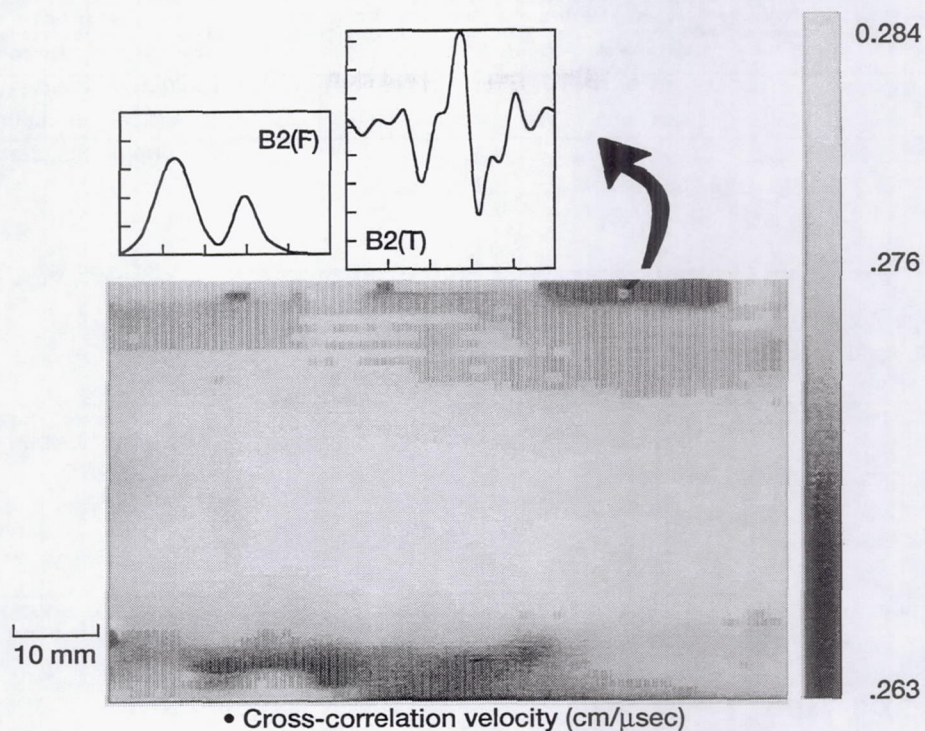
inhomogeneity even when the ultrasonic image does not indicate prominent inhomogeneity at that scan point. The use of these PMC materials in high-performance applications may require such analysis to pinpoint subtle variations in microstructure. The criterion used to flag distorted waveforms was that the Fourier magnitude of either of the back-surface echoes had a significant double-peaked characteristic. Figure 10 shows the ultrasonic velocity image of Figure 7 with several scan locations highlighted by short vertical lines. These locations are more prevalent at the porous (left), lower velocity end of the scanned region but do not show striking gray scale variations in relation to neighboring scan points in the image. However, time-domain back surface waveforms ( $B2(T)$ ) at these scan locations exhibited above average noise which resulted in a double-peak (destructive interference) characteristic for the corresponding Fourier magnitude spectra ( $B2(F)$ ) as compared to those for surrounding scan locations. It is likely that specific elongated pores or pore clusters caused ultrasonic scatter and the resulting distorted waveforms and destructive interference characteristic of the magnitude spectra. Another example of PSIDD analysis is shown in Figure 11 where a PMC panel exhibiting less than 1% pore fraction variation across the panel still has many locations near the top and bottom edges showing highly-distorted waveforms. In Figure 11, waveform distortion correlated with higher-than-average attenuation coefficient and lower-than-average velocity positions for most but not all positions.

Figure 10.—Post-scan interactive data display for waveform analysis. Scan locations highlighted by small vertical lines where waveforms distorted.

Figure 11.—Post-scan interactive data display for waveform analysis. Scan locations highlighted by small vertical lines where waveforms distorted.
